Norwalk PD Crashes

2015 TO PRESENT DAY

CONNECTICUT TRANSPORTATION SAFETY RESEARCH CENTER

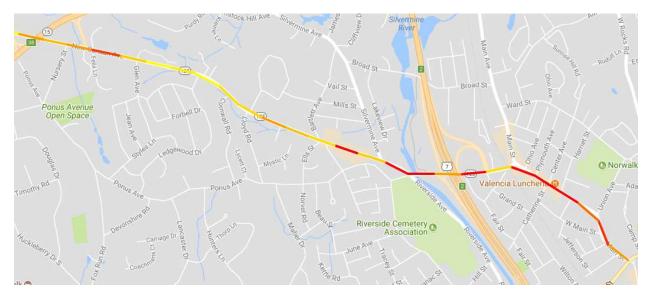
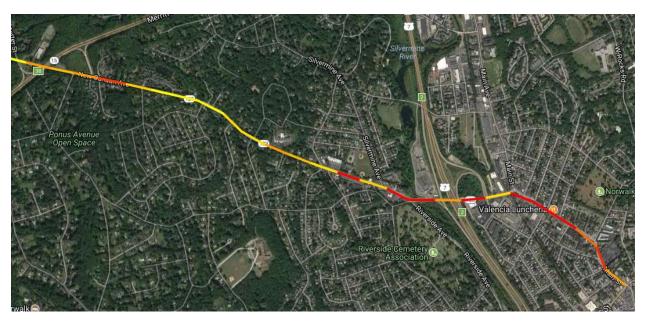
Route 123 North

- Crash congestion is the worst near the North Ave intersection of Route 123 and continues until
 just before Birchside Dr (around in front of Brightview retirement community)
- ♣ A second high-crash area is concentrated near the intersection of Route 123 and Glen Ave and continues north towards Carter St.

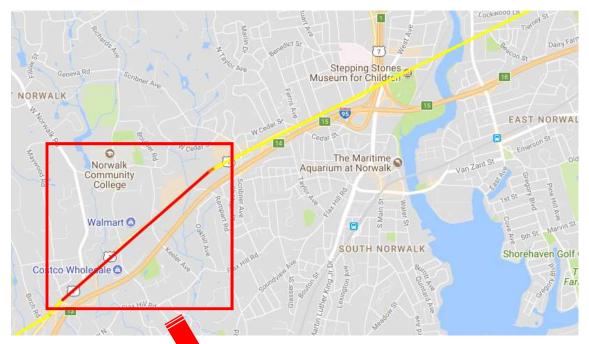
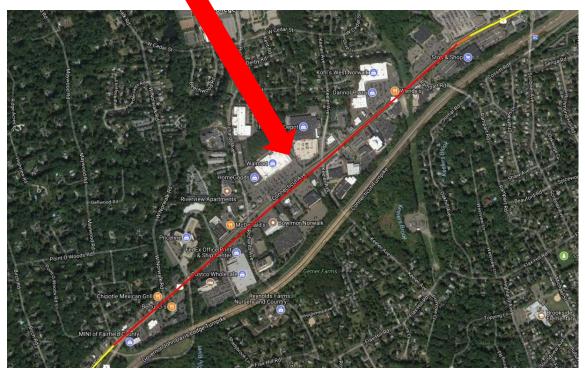
Route 1 South

Congestion begins at the Shop Rite plaza and continues down Route 1 until the Blue Wave Taco Restaurant (adjacent to Richmond Drive)

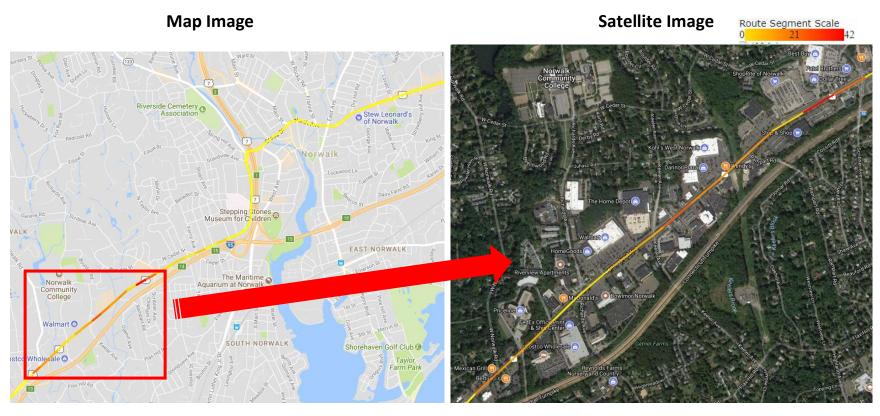
Route 1 North

- Crash congestion begins at about the Darien Car Clinic (between W Norwalk Rd and Richmond Dr) and continues the length of Route 1 until the intersection of Scribner Ave and Route 1
- ♣ Most crashes occurring between Scribner Ave and the entrance/exit for the Shop Rite parking lot

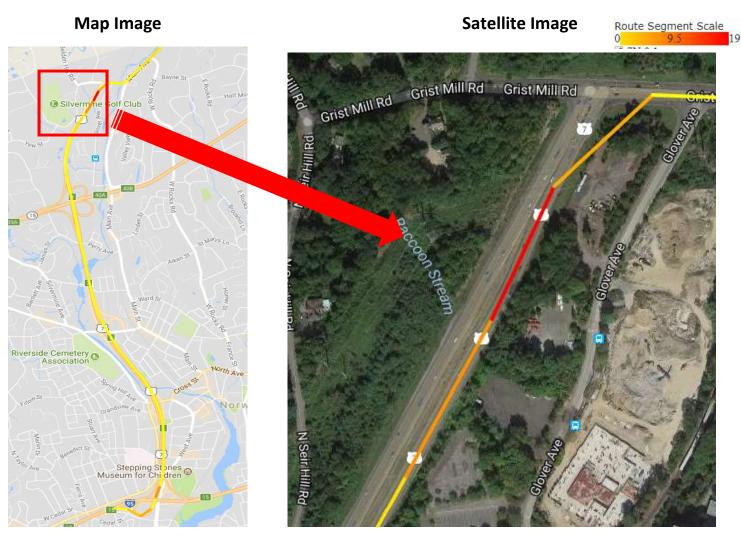
Route 7 North

- ♣ High crash concentration begins at the point that you turn off Route 7 onto Grist Mill Rd.
- → Additional congestion beginning at the exit Ramp from I-95, through the semi-circle onto Route 7 North.

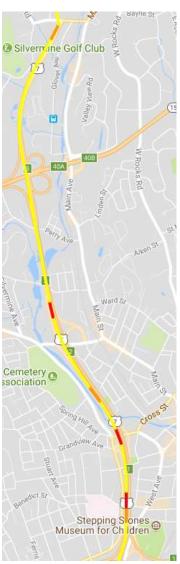
- Crash congestion begins near
 Grist Mill Rd
- More congestion just south of exit 2 and again, north and south of exit 1
- ♣ Lastly, congestion begins on route 7 near the north bound exit for route 1, all the way down to Matthews Park intersection

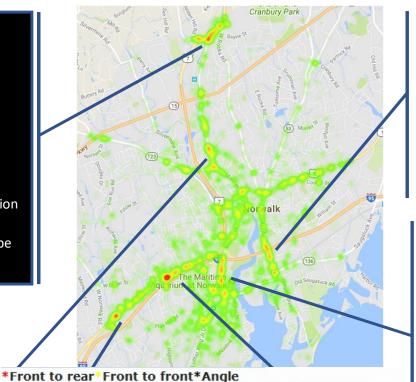
Manner of Collision in High-Density Crash Locations

39% of crashes were rear-ends and 13% were angle crashes. The second most common crash type were sideswipes in the same direction (15%)
